## A Floor Deformation of SACLA Building

Hiroaki KIMURA

*RIKEN SPring-8 Center, 1-1-1, Kouto, Sayo-cyo, Hyogo 679-5148, Japan*

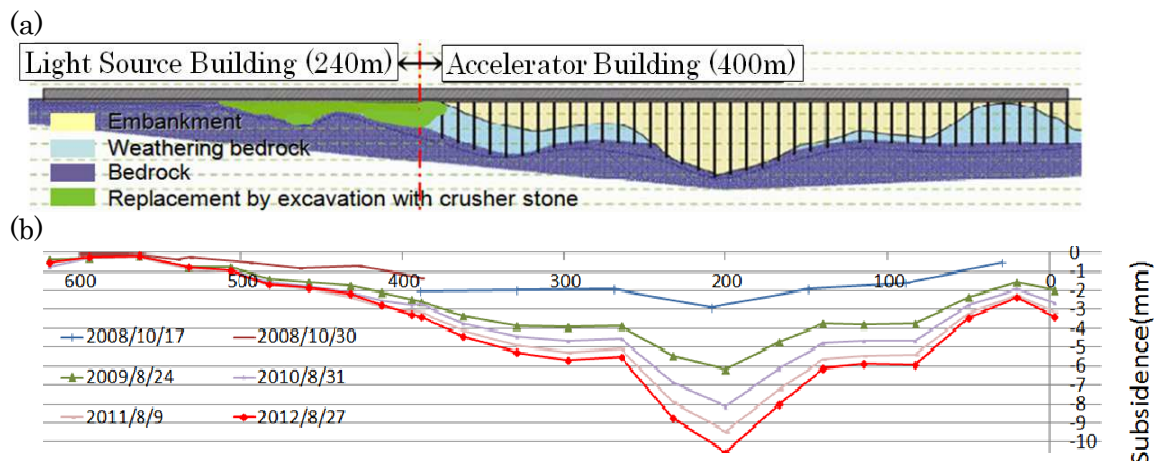
Generally, it is known that SPring-8 site is located on the very good ground, which is very stable and rigid bedrock. In contrast, the area of SACLA building is not rigid enough. Figure 1(a) shows schematic cross-section view of understructure of SACLA building and geological layers. The figure shows that the bedrock area (cutting area) is only 1/5 of the building and 4/5 of the building is located on the overlapping area. The maximum thickness of embankment is over 50 m.

The building was completed at March 2009. From construction phase of the building, the deformation of the floor is being measured. Figure 1(b) shows history of floor subsidence from August 2008. Recent maximum subsidence is 1 mm/year. This value is within the prediction. The shape of the subsidence data is very similar to that of embankment. Then subsidence is proportional to the thickness of embankment, not to the length of pillar.

**Figure 1:** (a) Schematic view of understructure of SACLA building and geological layers.

(b) History of subsidence of the floor from August 2008.
